AIRCRAFT ACCIDENT
INVESTIGATION REPORT

FEDERAL EXPRESS CORPORATION

N 5 2 6 F E

CRASH DURING LANDING
FEDERAL EXPRESS CORPORATION
MCDONNELL DOUGLAS MD-11F, N526FE
NARITA INTERNATIONAL AIRPORT
MARCH 23, 2009

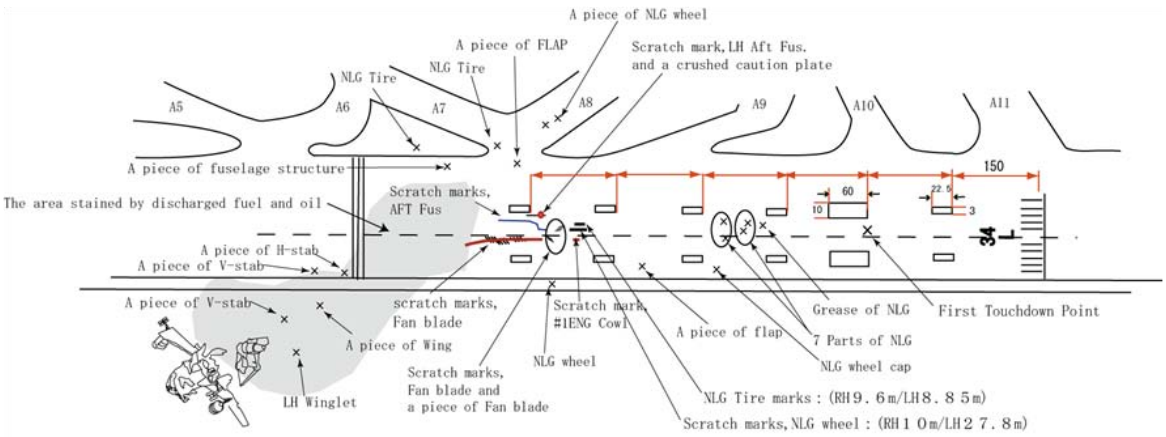
Figure 1　Overview of the Airplane's Wreckage

l. At 1,400 m from the threshold in the grass area to the left of the runway, there were the rear parts of the fuselage including the No. 2 engine.
m. At 1,450 m from the threshold in the grass area to the left of the runway, there was the nose section.

n. Fuel and oil discharged from the airplane spread over the runway with a length of 210 m and a width of about 50 m, and in the grass area with a length of 230 m and a width of 30-60 m.

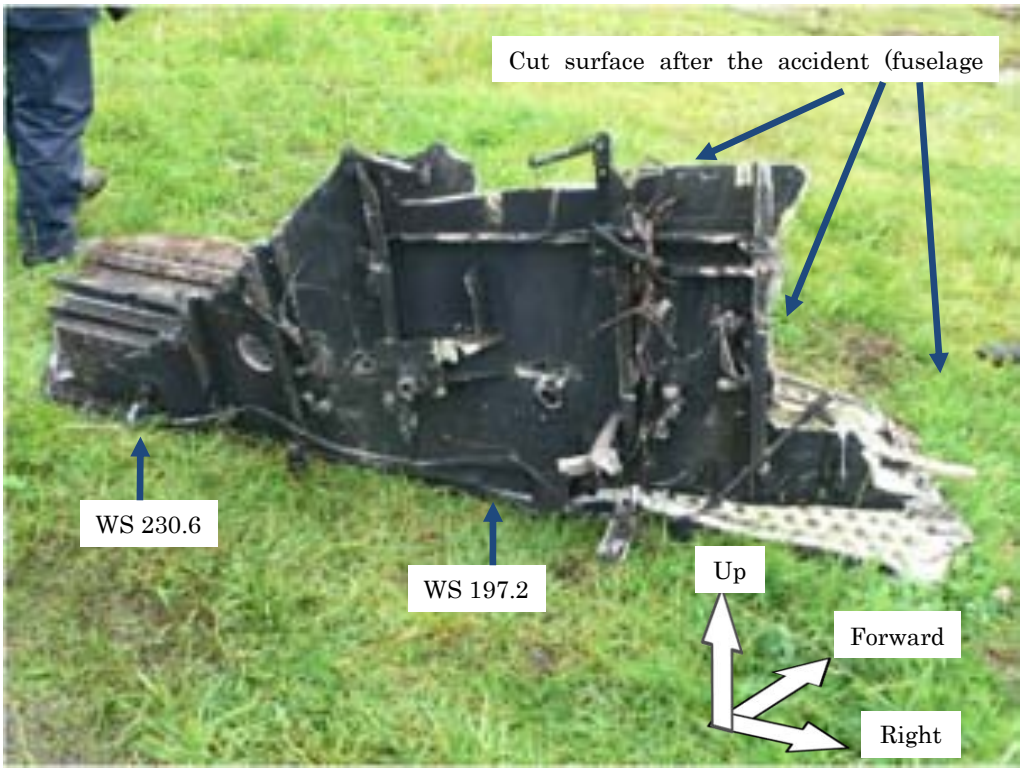
Photo 3 Fractured Area of Left Wing (Fuselage Side)

The front spars were vertically fractured at about 50 cm inboard (close to the wing root) of WS264.

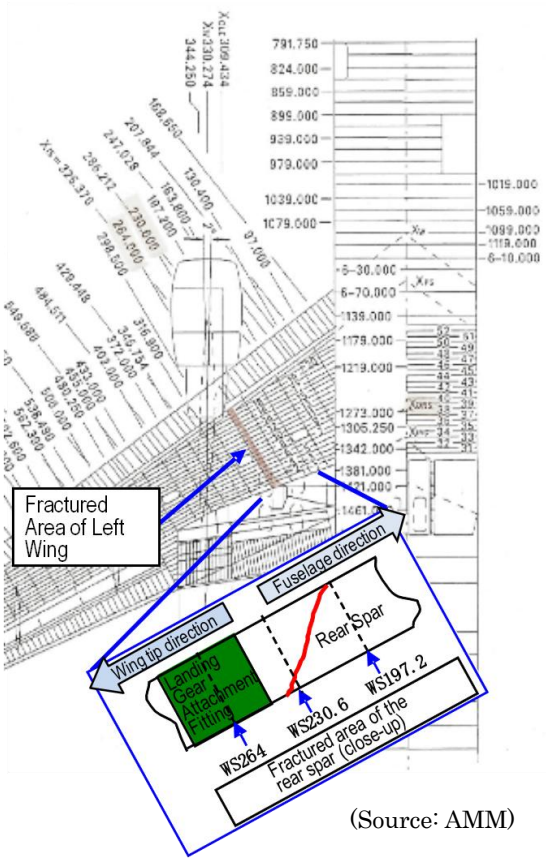
Figure 2 Fracture Surface of Left Wing

The fractured lower wing skin was applied with tension stress, forming openings between the skin and the stringer, with rivet heads broken. The skin near the rear spar was bent downward. (Photo 6)

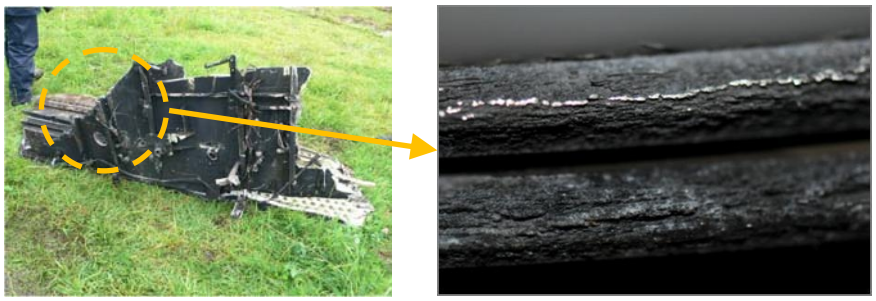
Photo 7 The fracture face of the left wing rear spar (fuselage side)

Fractured rear spar (except for the areas exposed to fire) was examined by JAXA. The fracture surface showed no indications of repetitive loads such as scratching. The examination showed that the spar fractured quickly under the excessive stress. (Photo 7)

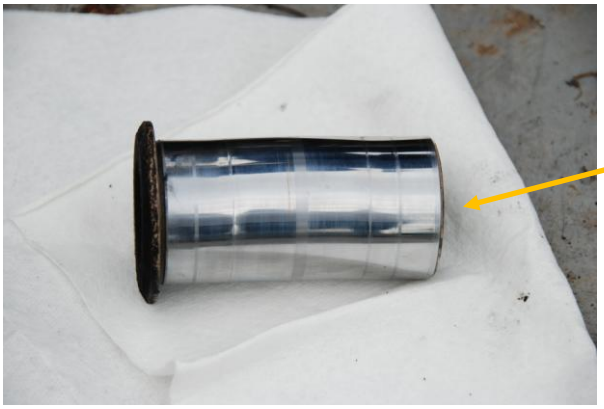
Figure 3 Left MLG-to-Wing Attachment

The left MLG remained attached to the left wing, and the retractable side brace and the fixed side brace were found attached to the MLG. The forward trunnion bolt (fuse pin) was slightly deformed, however, it did not fail. About the two bolts which were attached to the side brace fitting (pillow block) and the trapezoid panel, the inboard bolt was broken leaving part of it in the panel, while the outboard bolt was removed from the pillow block out of the broken bolt hole, remained in the pillow block with the landing gear. A

lug, which is connected to the lower end of the landing gear, was torn apart. The sooted left MLG strut was fully extended with no apparent damage. The surface of the four wheels and tires were all burned and sooted. There were slight traces of scratch on the two outer wheels. No. 5 and No. 6 tires were deflated without any indications of burst. The torque link was undamaged. The MLG attachment fitting had no damage, but in the lower part of fitting, there was dent caused by the strut. (See Photos 9, 10 and 11, Figure 3)

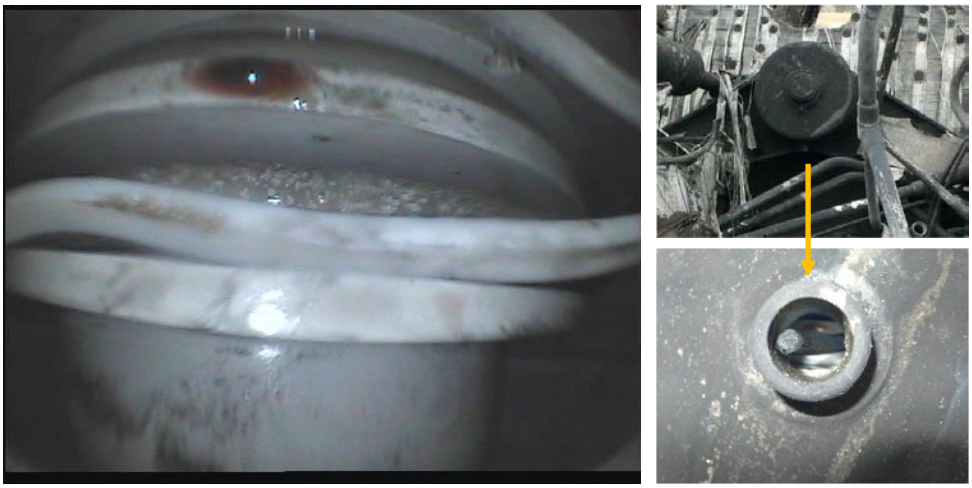
Photo 12 The Inside of the Blow-out Hole of Center MLG

The center MLG remained attached to the inverted fuselage, but as the fire consumed the fuselage interior, it somewhat drooped into the body. Borescope image (See Photo 12) through the strut blow-out hole shows the smashed crush tube*4, indicative of a strut bottoming. (See Figure 4)

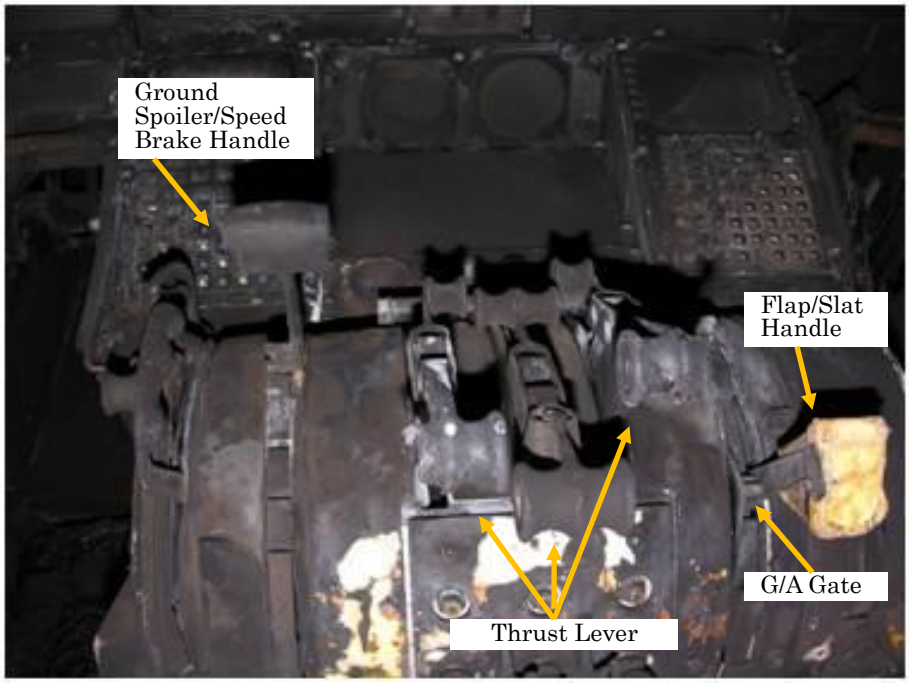
Photo 16 Center Pedestal

The flap/slat handle was in 28º G/A (go-around) gate. The No. 1 thrust lever was in the mid-forward position, the No. 2 lever in the backward (pulled) position and the No. 3 lever in the forward (pushed) position. All reverse levers were in the retracted (not for use) position, while the ground spoiler/speed brake handle was in the retracted position. The engine fire handle on the overhead panel was in the UP position.

NAV select switch, Flap Limit Feel switch and the Elev. Feel Switch were in AUTO position.

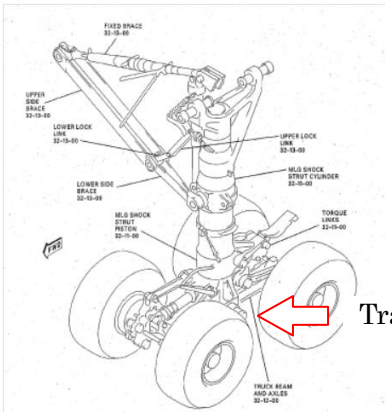
Photo 17 Track Beam Bolt

The left MLG had no exterior damage except for the fire damage or that caused by the movement from the accident site to the storage site. The longitudinal straightness of the outer diameter of the track beam bolt (parts number: ARG7373-1), which transfers the loads on the landing wheels to the struts, was measured with a thickness gauge at JAXA, and a gap of 0.03-0.04 mm was observed. The residual deformation generated the gap, and the gap was made as a result of the plastic deformation occurred to the bolt when it was exposed to a load.

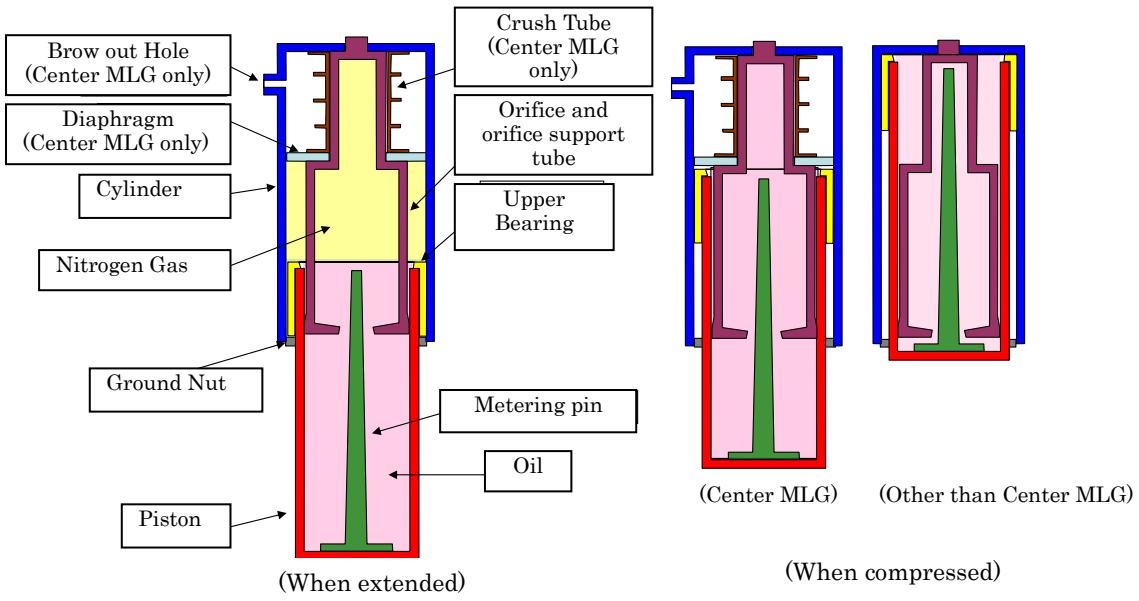
Figure 4 Mechanism of NLG/MLG Strut

The Landing Gear strut is completely compressed as shown in Figure 4, when they are shipped from a maintenance facility. Before installation, the strut is inflated with nitrogen

gas up to the regulated pressure. At landing, nitrogen gas is compressed from the extended position and the fluid is forced to pass through the orifice that generates the resistance of fluid flow so that the landing gear absorbs the landing force.

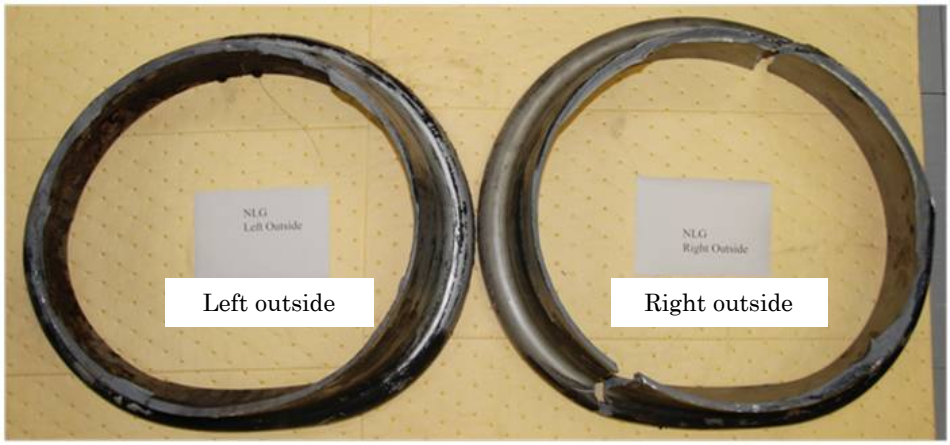
Photo 19 Fractured Pieces of NLG Wheels (Rim)

(1) The rims were fractured with a upward load,
(2) The wheel halves, which form the wheel hub, were extended outward and deformed to opening direction, and
(3) The threads of the tie bolts and the nuts were fractured.

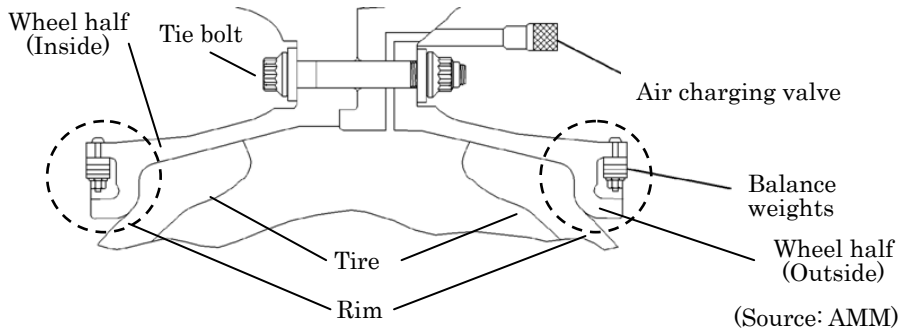
Figure 5 Cross-sectional schematic of NLG Wheel Hub

(1) Large upward load applied upon touchdown of NLG caused the tire to expand sideways,
(2) The rims were fractured with the bending load, while the wheel halves were forced to expand sideways stretching the tie bolts, and
(3) The fracture of bolts' and nuts' threads made the nuts loose.

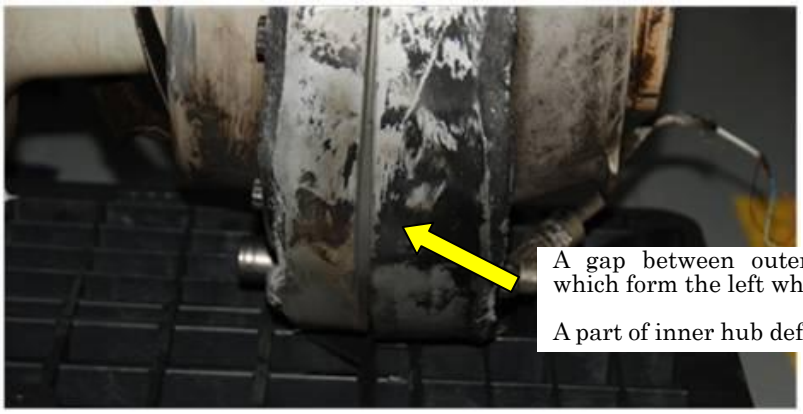
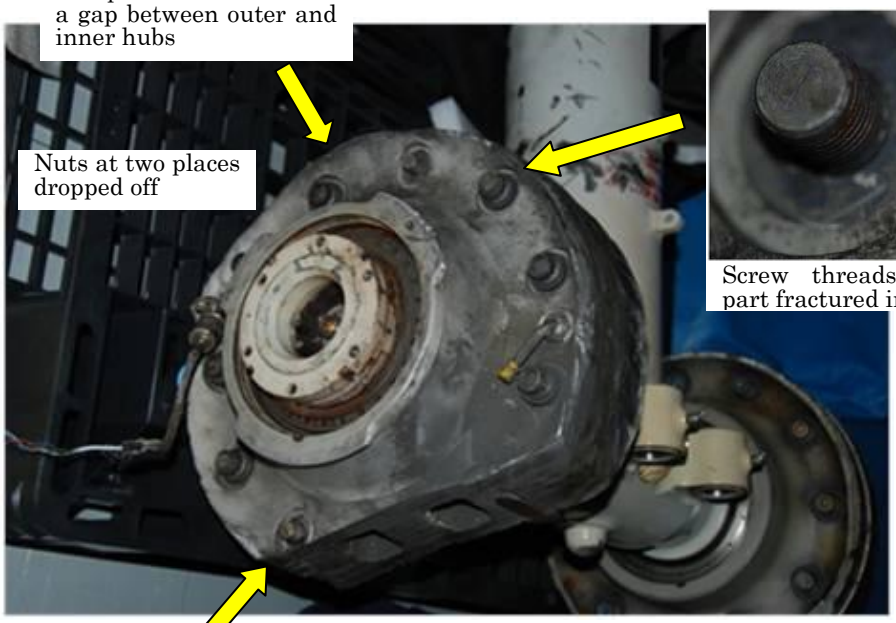
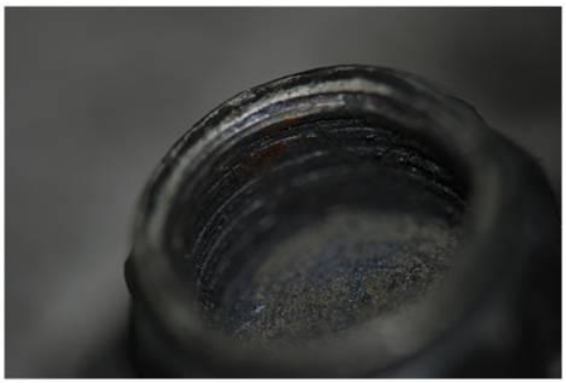
Photo 20 NLG Left Wheel Hub

A gap between outer and inner hubs which form the left wheel

A part of inner hub deformed to the inside

Nuts at two places dropped off

Screw threads of central part fractured in shear

Scratch mark with washer (Nuts displaced by scraping with the ground.)

The inside of loosened nut (screw threads shaved, about to come off with tensile load)

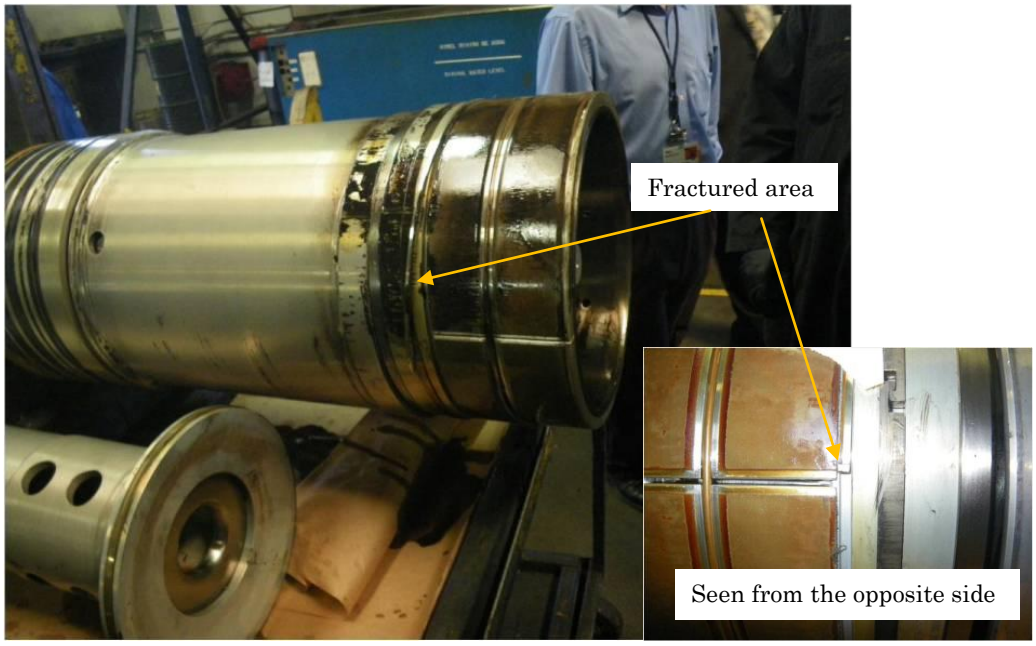
Photo 21 Left MLG Upper Bearing

Visual examination of the left MLG strut found no visible damage. The examination of the MLG components found no major damage with exception that the lower lip of the upper bearing (the inner part that supports the upper end of the piston) completely separated from the bearing halves at the place where it is connected to the other components.

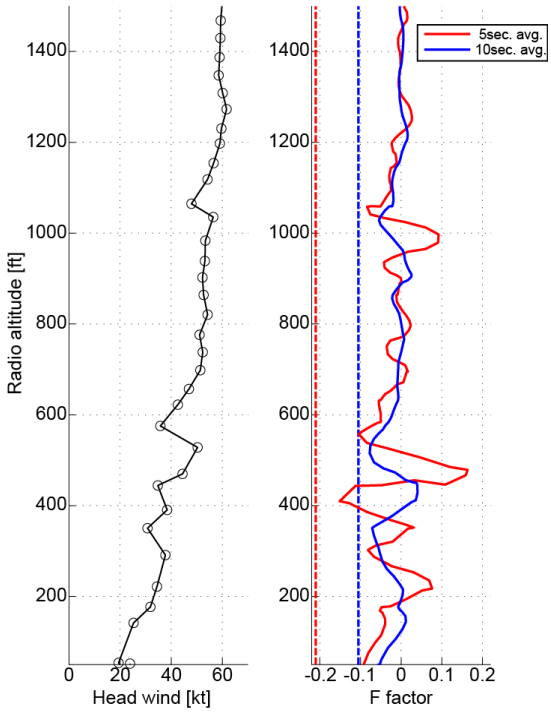
Figure 6 Evaluation of Operation of Windshear Warning Device

According to the DFDR records, a head wind component of the horizontal winds which the airplane encountered below 1,500 ft RA were about 60 kt at 1,000 ft or above, about 50 kt from 1,000 ft to 500 ft, and about 25 kt near the ground, meaning that there were the wind velocity difference of about 25 kt between the ground and 500 ft or more. (Figure 6) The onboard windshear warning device was functional and didn't activate the windshear warning.

According to FAA TSO-C117a, which prescribes the minimum performance standards for the windshear warning systems, the system generate an alert when the F Factor*7 exceeds the threshold value (-0.21 on a 5 second average and -0.105 on a 10 second average). The F Factor (Figure 6), estimated with the DFDR records, was below the thresholds both on a 5 second average (red broken line in Figure 6) and a 10 second average (blue broken line in Figure 6).

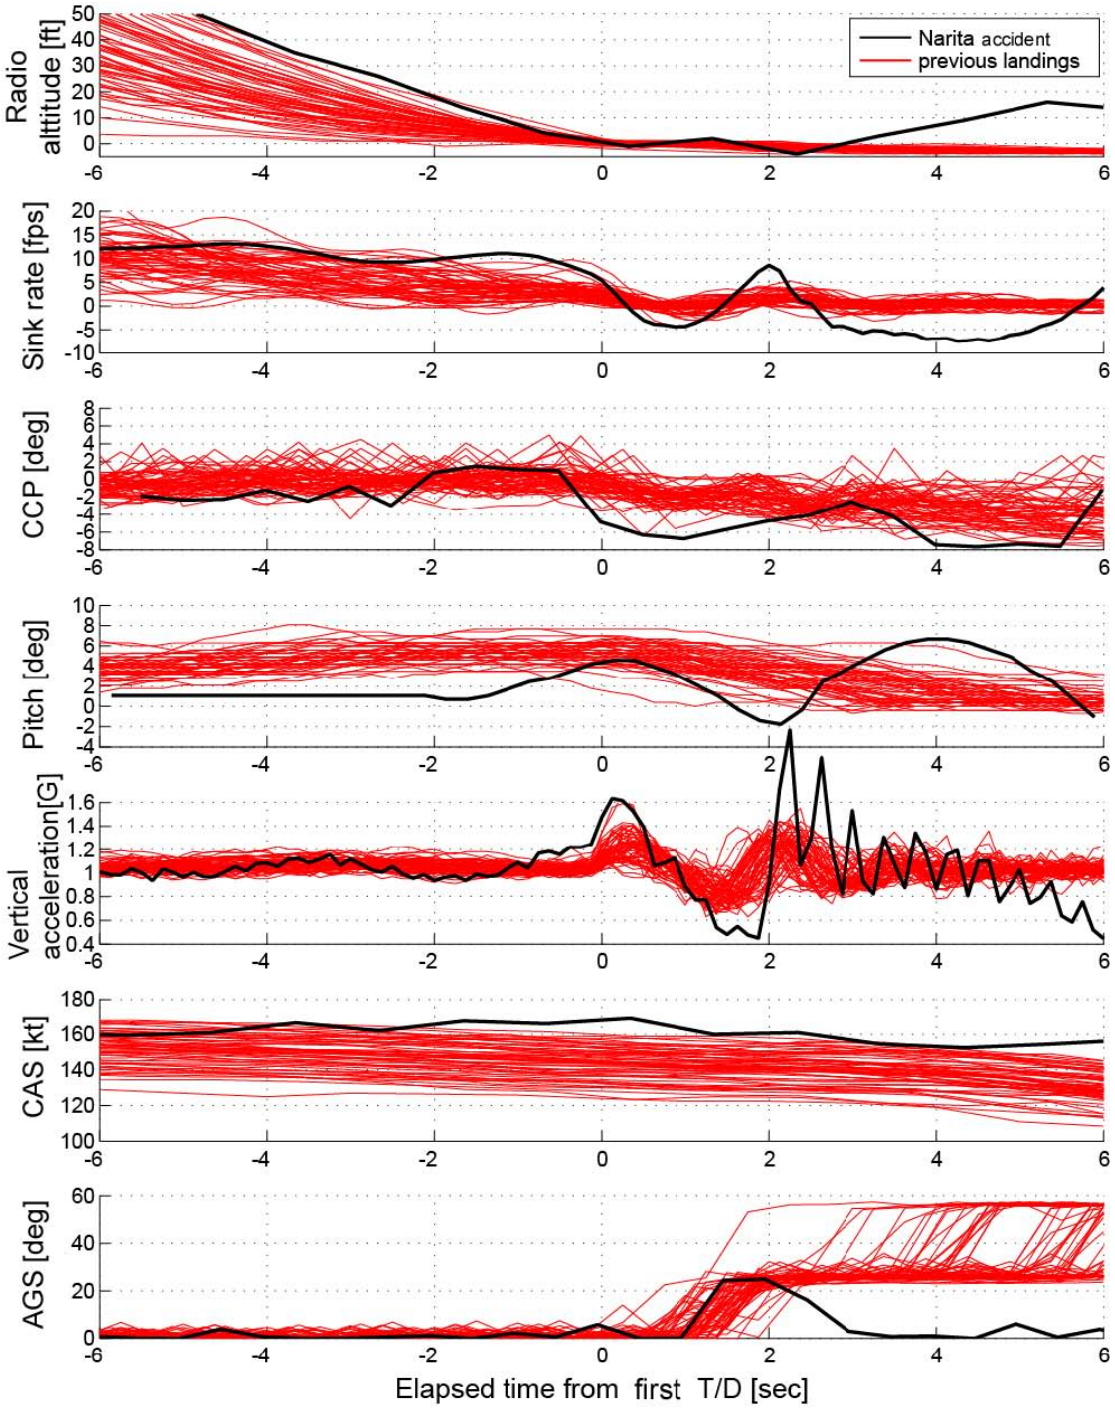
Figure 7 Comparison of the Accident Landing with Previous 60 landings

To get a clearer landing profile of the accident landing, the accident landing was compared with previous 60 landings recorded in the quick access recorder (QAR), synchronizing the first touchdown timing. The study revealed following distinctive aspects. (See Figure 7)

a. The descent angle and the sink rate are large until touchdown. The sink rate at 50 ft RA was about 13 fps and the sink rate at touchdown was about 7 fps.
b. The control column input just before and during the touchdown is large. The control column was pulled backward about 2 seconds before touchdown, held there and pushed forward with large stroke just before the touchdown.
c. Pitch attitude variation just before and during the touchdown are large. The airplane approached with the smallest pitch angle until flare and the pitch angle increased rapidly just before the touchdown. Then, the pitch angle decreased rapidly to negative when it made the second touchdown.

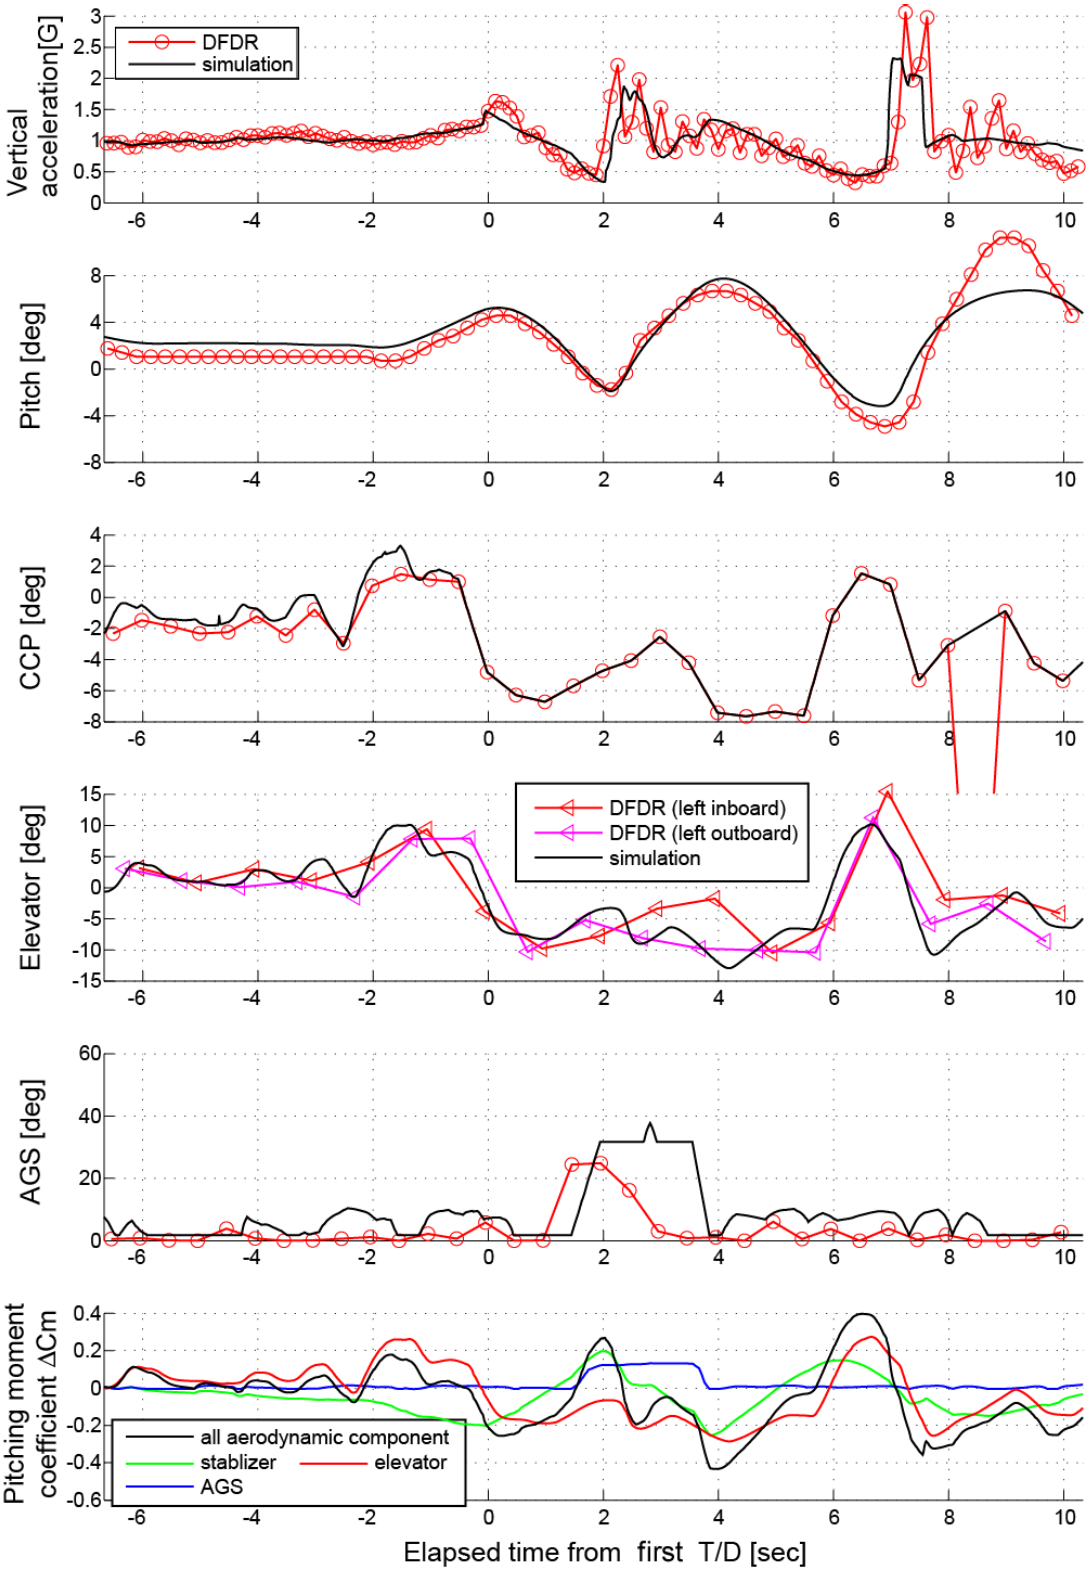
Figure 8 Factors Linked to Pitch Attitude Variation

The observed pitch attitude variations were large in this accident. Therefore, contributing factors to the pitching moment were examined by using a flight simulation program made by the airplane manufacturer. The examination revealed the following: (Figure 8)

c. Ground spoiler deployment generates nose-up pitching moment.

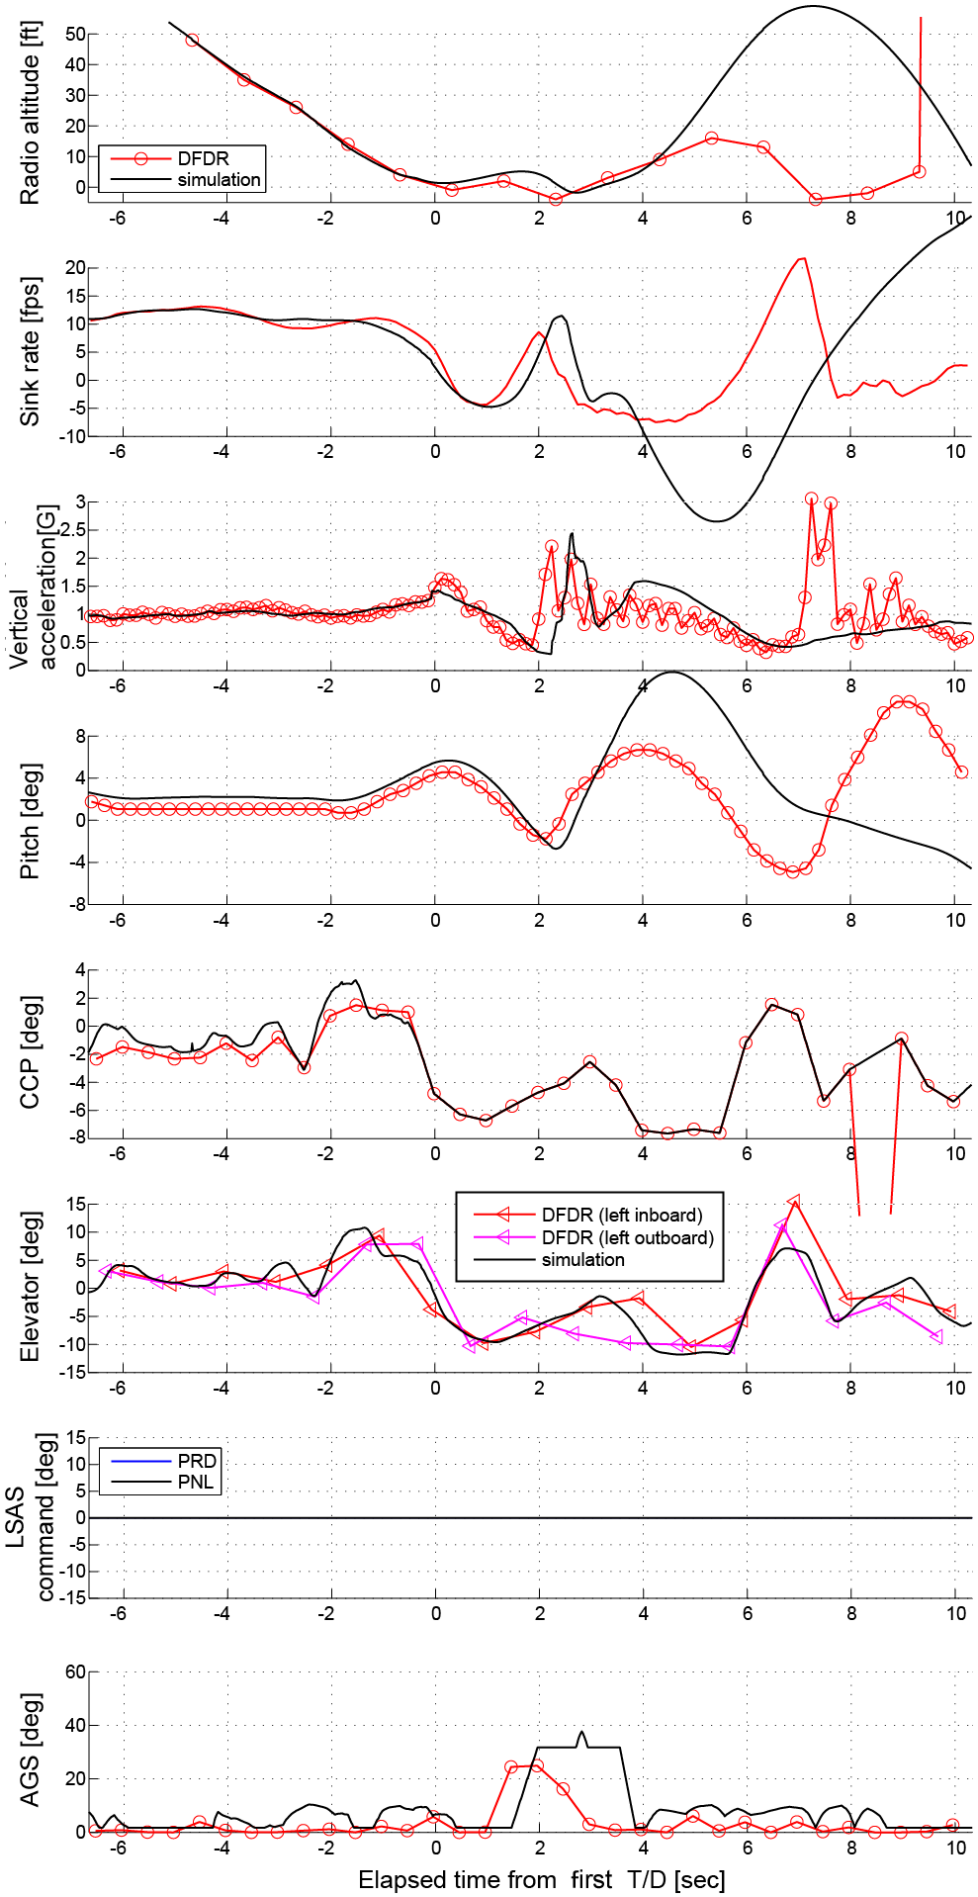
Figure 9 Simulation with LSAS Off

LSAS has the PNL function which issues nose down commands following the MLG touchdown and the deployment of the AGS. With the assumption that the LSAS had influenced the nose down motions during the two bounces, the influence of LSAS was examined using the flight simulation program made by the designer/manufacturer. The examination revealed the following. (Figures 9, 10)

The PRD function to moderate the pitch attitude change has greater influence on the airplane than the PNL function. Therefore, a final LSAS command during the PNL function operation usually ended up in the nose-up direction.
b. In a simulation with LSAS off, the pitch attitude and the bounce after the second touchdown were larger, when compared to this accident. The sink rate at the third touchdown was also larger than 21.5 fps recorded in this accident.
c. It is highly probable that LSAS had eventually worked in pursuit of curbing the pitch attitude variations.

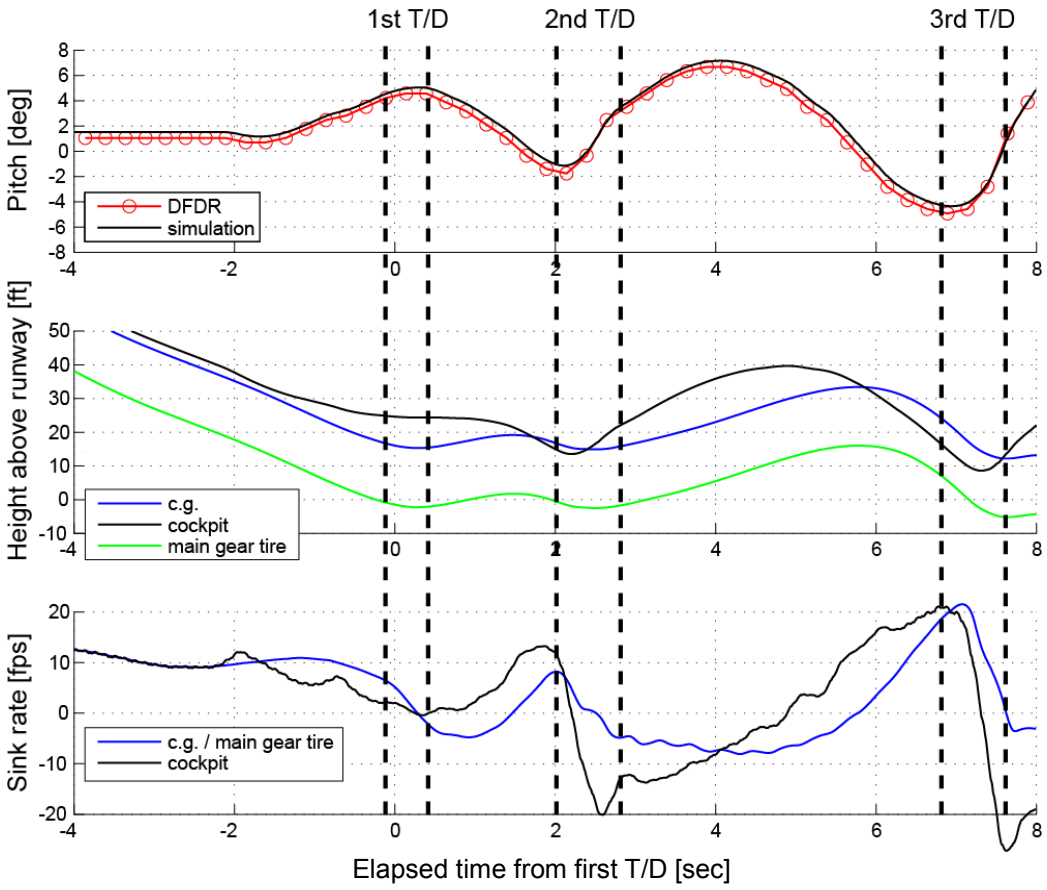
Figure 11 Analysis of Pilot's Eyes (Place) on Touchdown

The cockpit of MD-11 series airplane is far ahead (by 31 m) of the CG. Hence, when the pitch attitude variation is large, as was the case in this accident, it is possible that the cockpit height changes differently from that of the CG. Hence, the height of the CG, cockpit and MLG tires (height above runway) were examined with the flight simulation program made by the airplane manufacturer. As the compression of the landing gear strut is not taken into account, some MLG heights are shown below zero. (Figure 11)

b. At the time of the first bounce, the CG and MLG tires moved up about 4 ft. Meanwhile, the cockpit sank about 9 ft not going up, due to the pitch angle decrease.

c. About 3 seconds after the second touchdown, the cockpit reached the highest point of about 40 ft. About 1 second later, the CG and the MLG tires reached the highest point of about 33 ft and 16 ft, respectively.

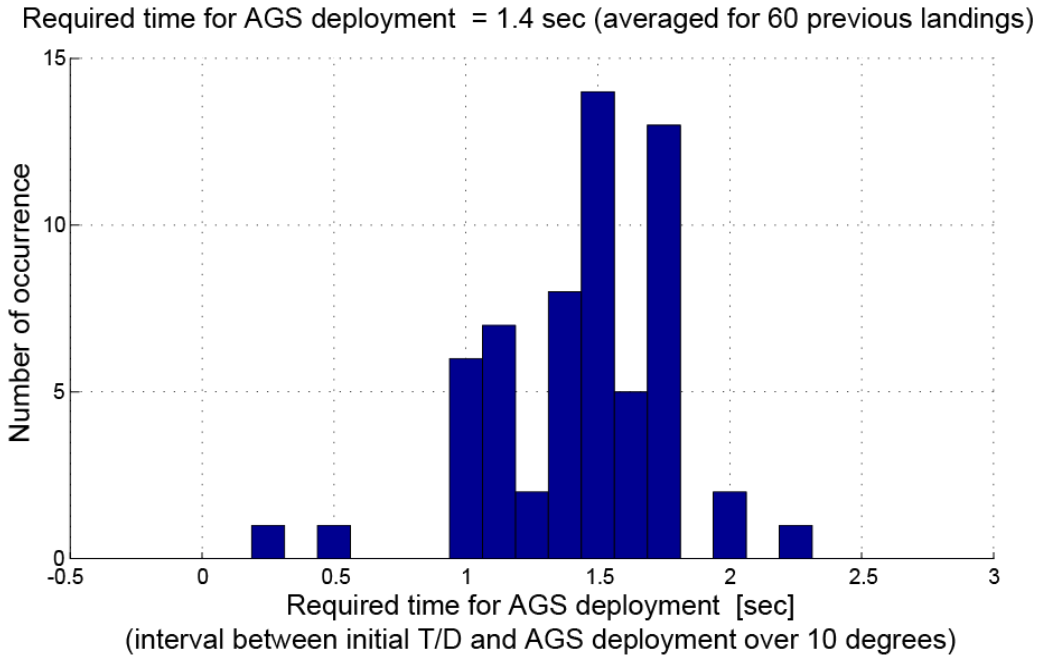
Figure 12 Observed Required Time for AGS Deployment in the Previous 60 Landings

The designer/manufacturer's manual states that the AGSs deploy up to 30º upon the MLG touchdown by sensing the MLG wheels spin-up, and continue to deploy to 60º maximum upon the NLG touchdown by sensing the compression of the NLG strut. The DFDR records show that the AGS angle in this accident was about 25º maximum.

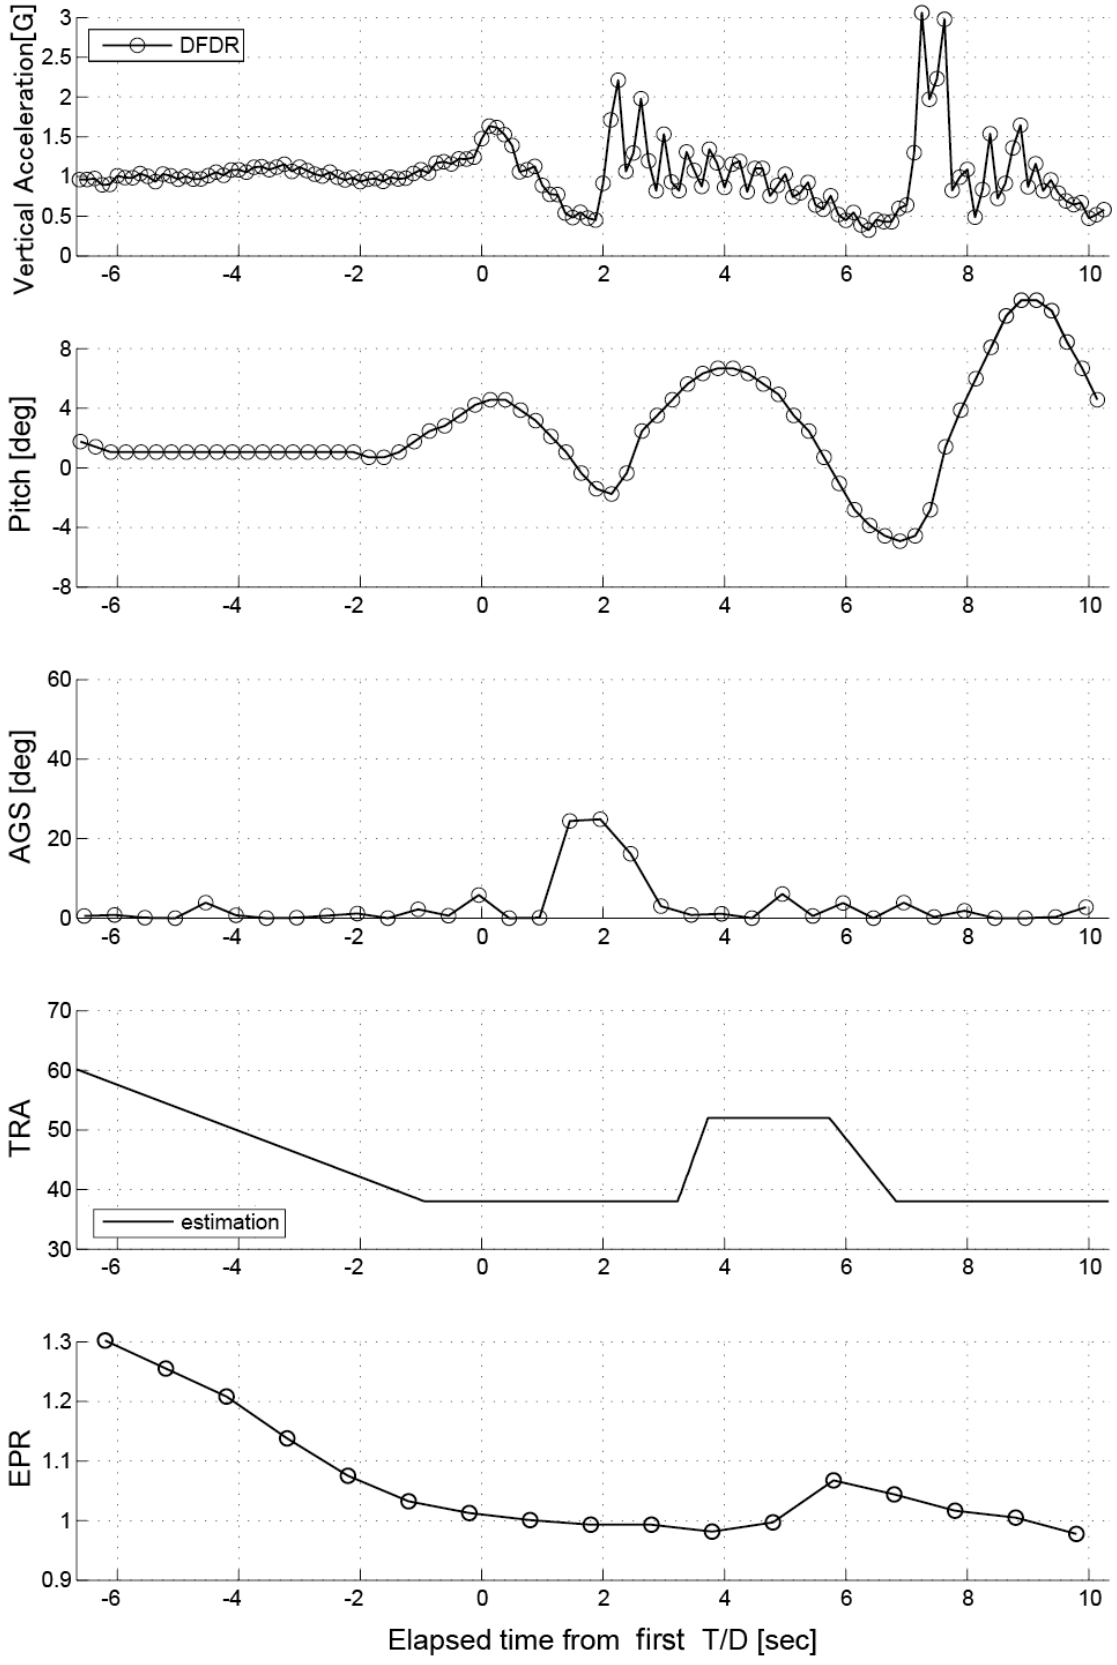
Figure 13 AGS Retraction

(2) According to the TRA estimation, the No. 2 engine thrust lever was advanced about 3.2 seconds after the first touchdown.

(3) Above mentioned findings suggest that the AGS was retracted almost at the same time when the No.2 engine thrust lever was advanced.

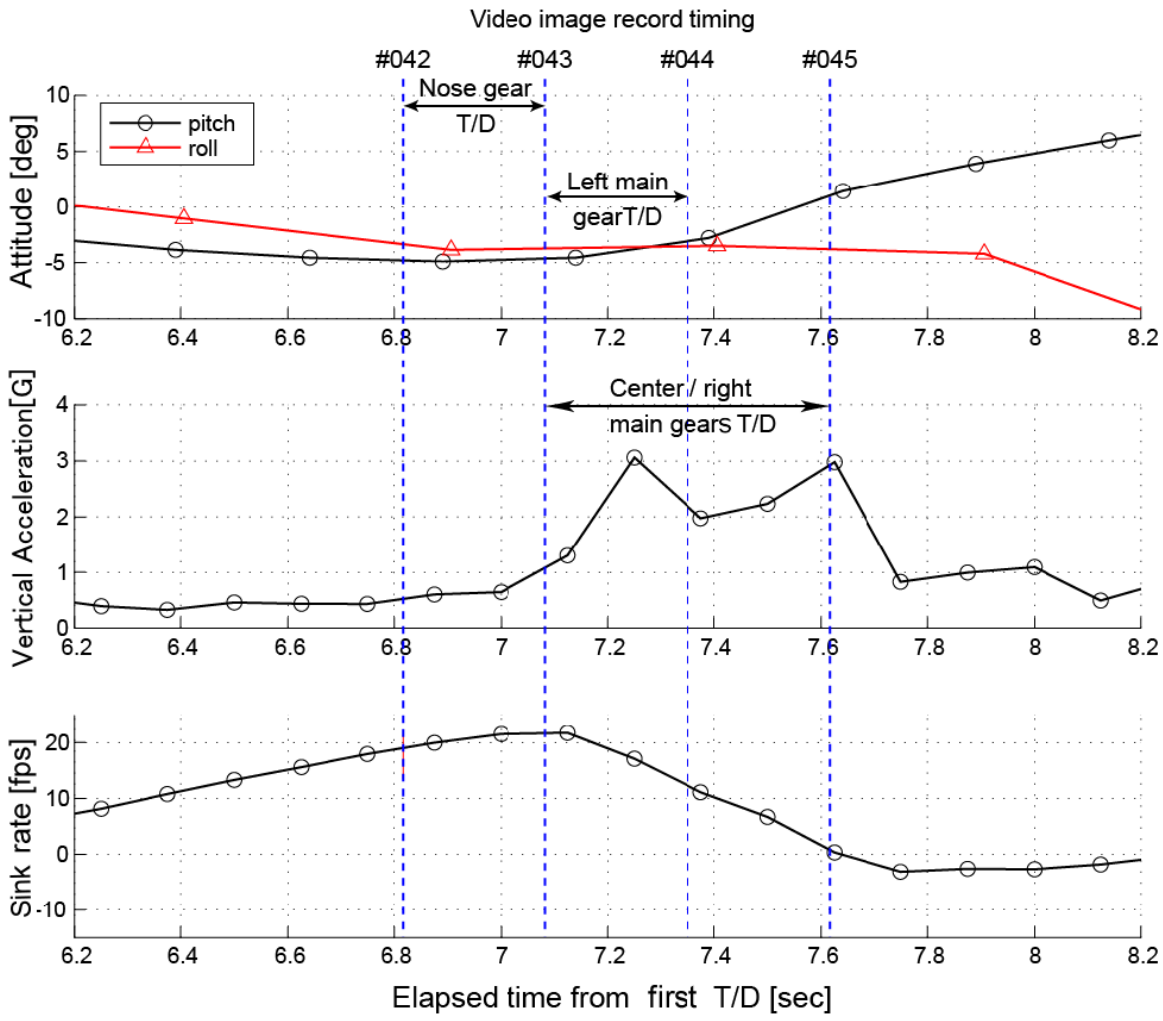
Figure 14 Estimation of Third Touchdown Status

These Images and DFDR records are synchronized to be shown in Figure 14. The synchronization was made by comparing calculated sink rate from the image analysis with that from the DFDR records.

The touchdown timing calculated from the Images corresponds to the attitude and acceleration data from the DFDR records; The following reasons made it impossible to get more detailed touchdown timing of each landing gear:

a. The Camera Images interval was about 267 milliseconds,
b. The number of pixels in each pictures was 672 by 224, and
c. The recorded time in the Camera Images had not aligned to JST/UTC, so there were some time errors.

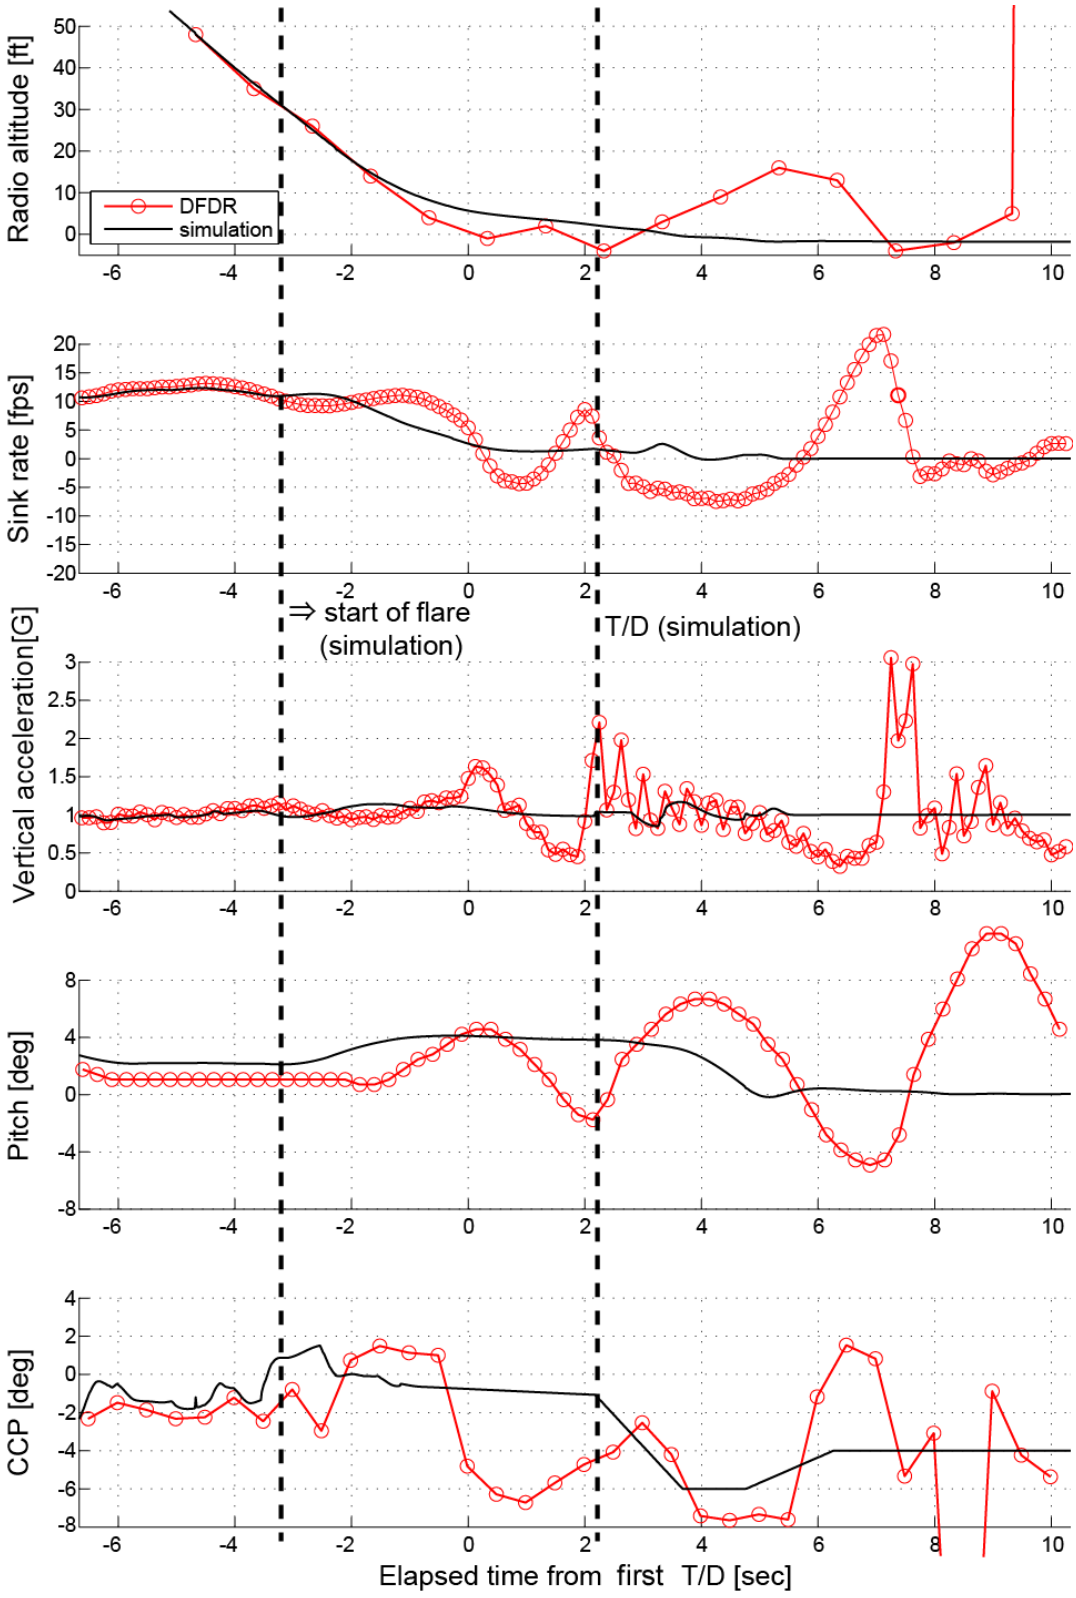
Figure 15 Simulation for a Case When the Flare is Started from 30 ft RA

The airplane behavior was examined for the case where the airplane approaches in the same manner as in this accident until 30 ft RA and starts flare at 30 ft RA. The examination revealed the following: (Figure 15)

a. The DFDR records show that the sink rate did not decrease until around 10 ft RA and it remained still 7 fps when the airplane touched down. Meanwhile, in the case of flare start at 30 ft RA, the sink rate began to decrease around 20 ft RA and the sink rate decreased to 2 fps at the time of touchdown.
b. When the flare started at 30 ft RA, the vertical acceleration on touchdown was about 1.1 G. The bounce height after the touchdown was limited, and the vertical acceleration on the second touchdown after the bounce was about 1.2 G. This means if the flare had started in an appropriate manner at 30 ft RA, large bounces after the touchdown, such as seen in the first and second touchdowns which triggered this accident, would have not occurred.
