AIRCRAFT ACCIDENT
INVESTIGATION REPORT

FEDERAL EXPRESS CORPORATION

N 5 2 6 F E

CRASH DURING LANDING
FEDERAL EXPRESS CORPORATION
MCDONNELL DOUGLAS MD-11F, N526FE
NARITA INTERNATIONAL AIRPORT
MARCH 23, 2009

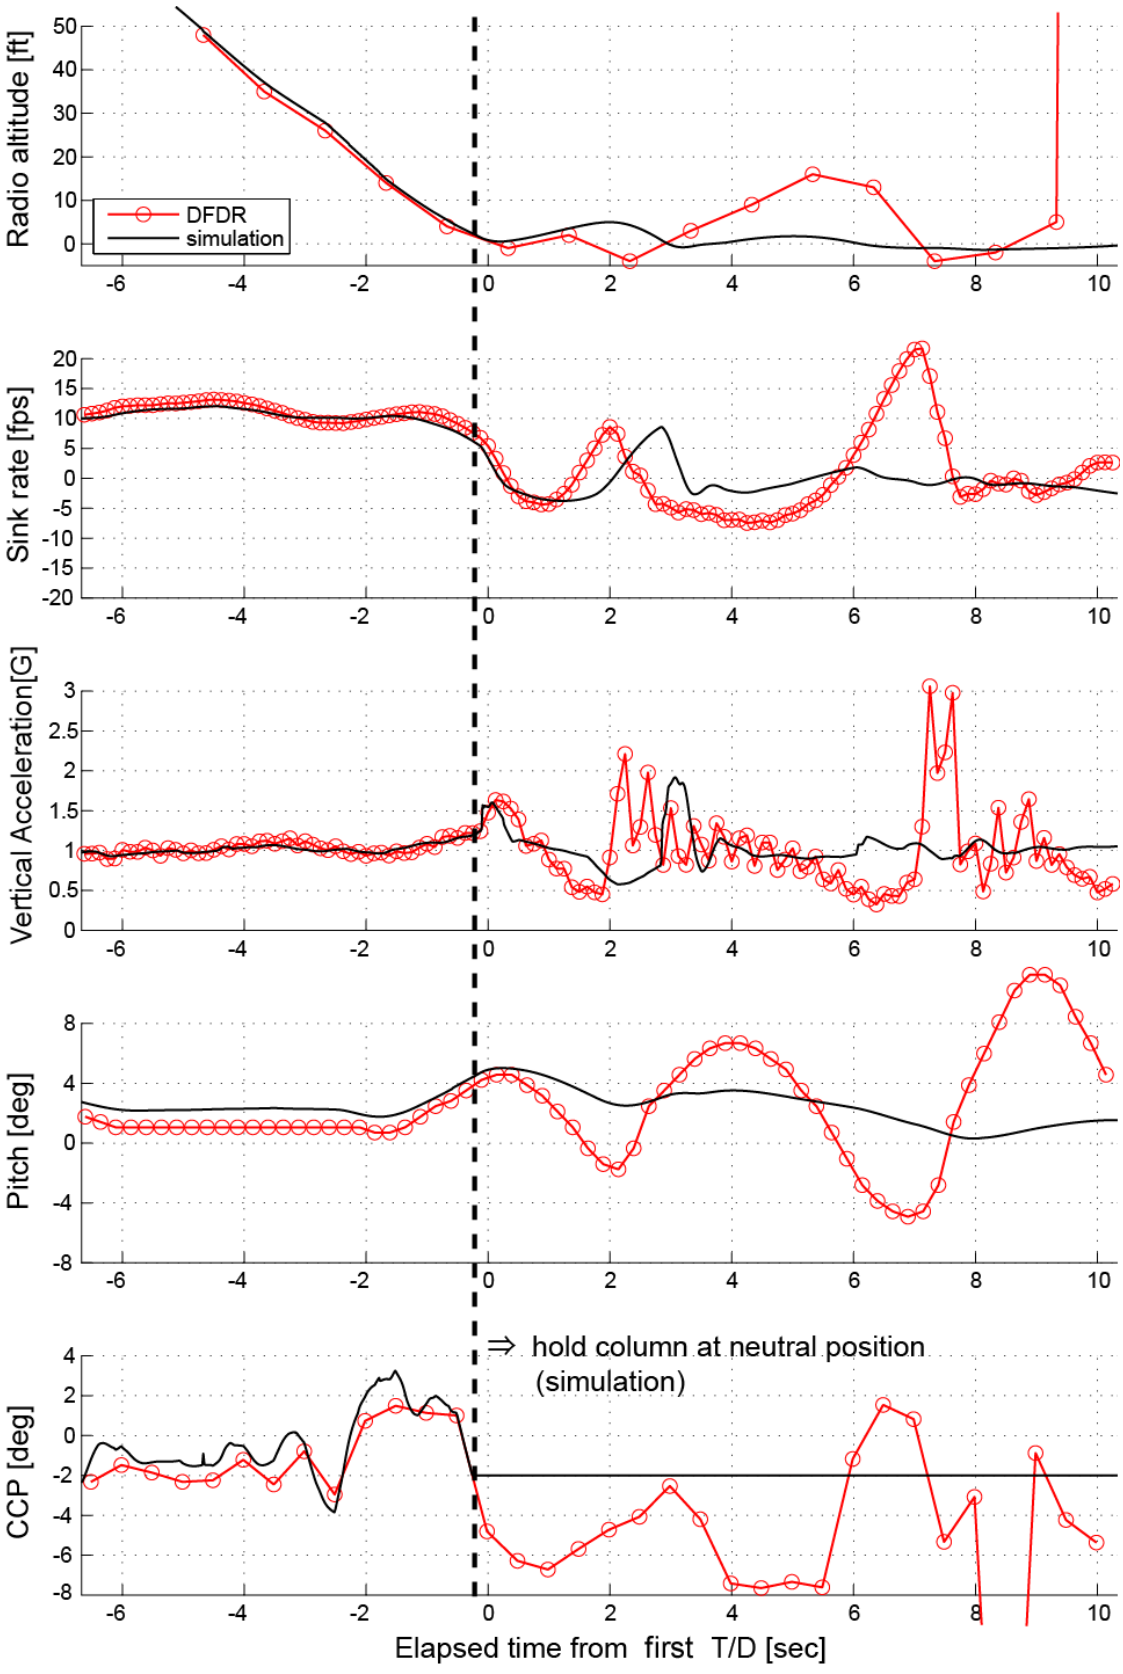
Figure 16 Simulation for a Case Where a Nose-Down Column Input Held at the Neutral Position Just Before First Touchdown

As described in 2.14.4, the elevators deflections corresponding to the control column input, have the largest influence on the pitch attitude variations just before and after the first touchdown and the nose-down motions during the two bounces. The airplane behavior was examined in the case where the nose-down control column input just before the first touchdown is limited to the neutral position (-2°) and held it thereafter. The examination revealed the following: (Figure 16)

a. The maximum pitch angle after the first touchdown was 5.0° and there was no significant difference from that of 4.6° recorded in this accident.
b. Although the first bounce was larger than that of the accident, the second bounce was quite small. No large pitch attitude variations occurred, either.
c. The airplane landed on the MLG first at the second touchdown with almost the same sink rate of the second touchdown as that of the accident.
d. The maximum vertical acceleration (1.9 G) was observed upon the second touchdown, but it was far less than the airplane tolerance limit which leads to a destruction.

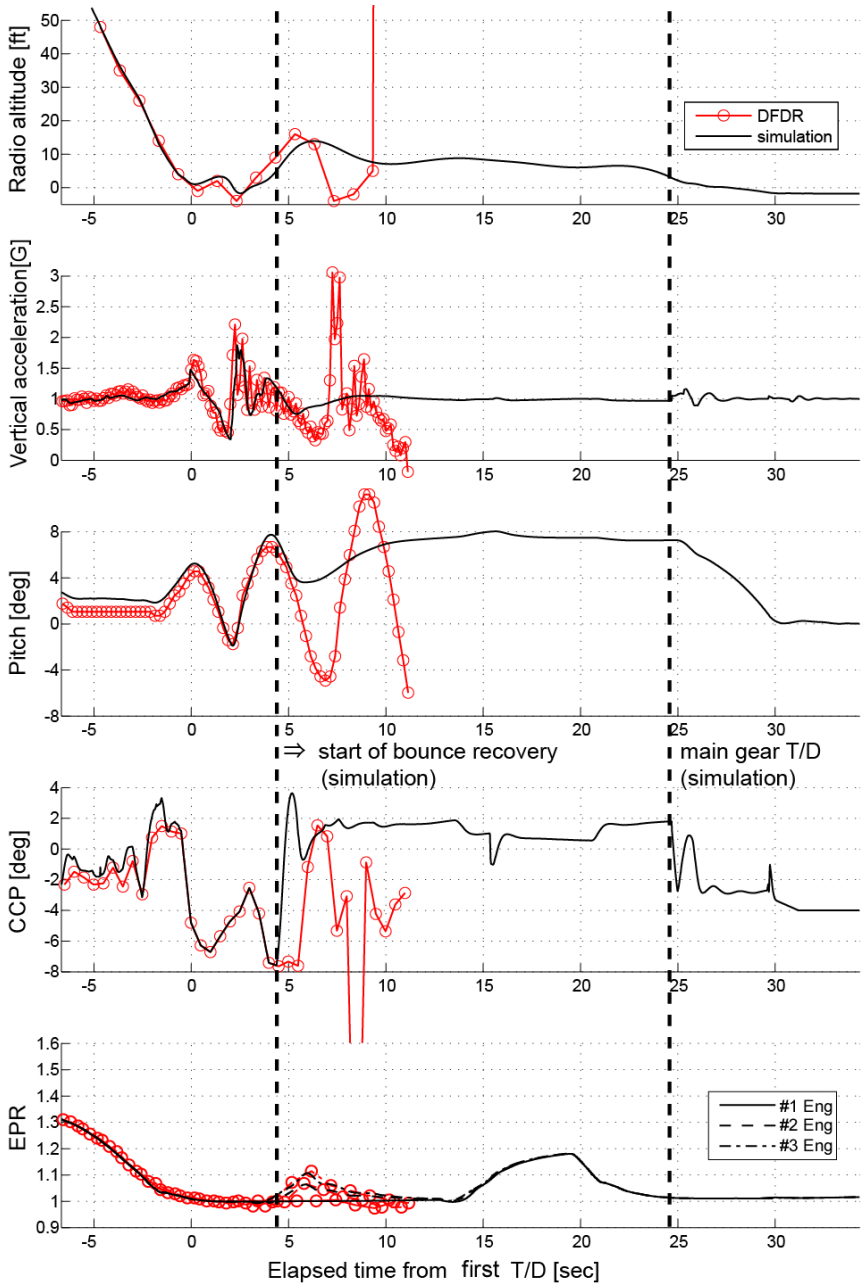
Figure 17 Simulation for a Bounce Recovery Operation during the Second Bounce

The airplane behavior was examined in the case where a bounce recovery is initiated at 5 ft RA during the second bounce. The results are as follows: (Figure 17)

b. Sink rate control by maintaining pitch angle 7.5° together with added thrust made it possible to limit the vertical acceleration on the third touchdown to less than1.2 G.

However, the timing of the third touchdown is prolonged until 22 seconds after the second touchdown by this bounce recovery. Considering that appropriate attitude and power control are necessary during that recovery operation and also additional runway length is required, the bounce recovery may not be practical.

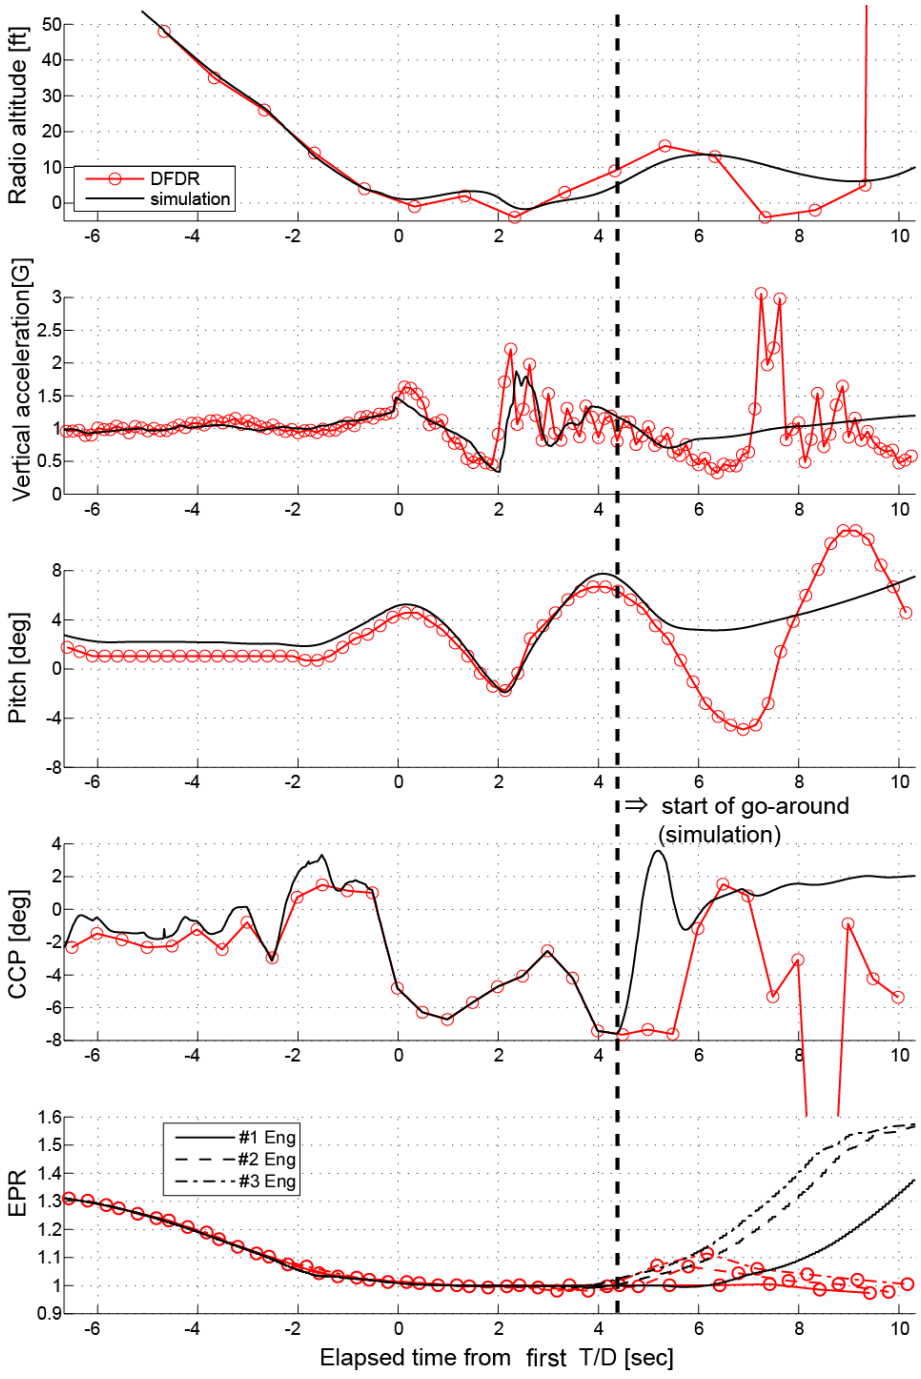
Figure 18 Simulation for Go-around during the Second Bounce

The airplane behavior was examined in the case where a go-around is initiated at 5 ft RA during the second bounce. The results are as follows: (Figure 18)

a. The pitch angle had already begun to decrease at the time of the go-around initiation, but even at this stage the subsequent rapid nose-down motion could have been avoided with large backward column inputs, and negative pitch attitude could have been avoided.

b. A go-around was possible before the third touchdown by increasing the thrust simultaneously with a nose-up control column inputs mentioned above.

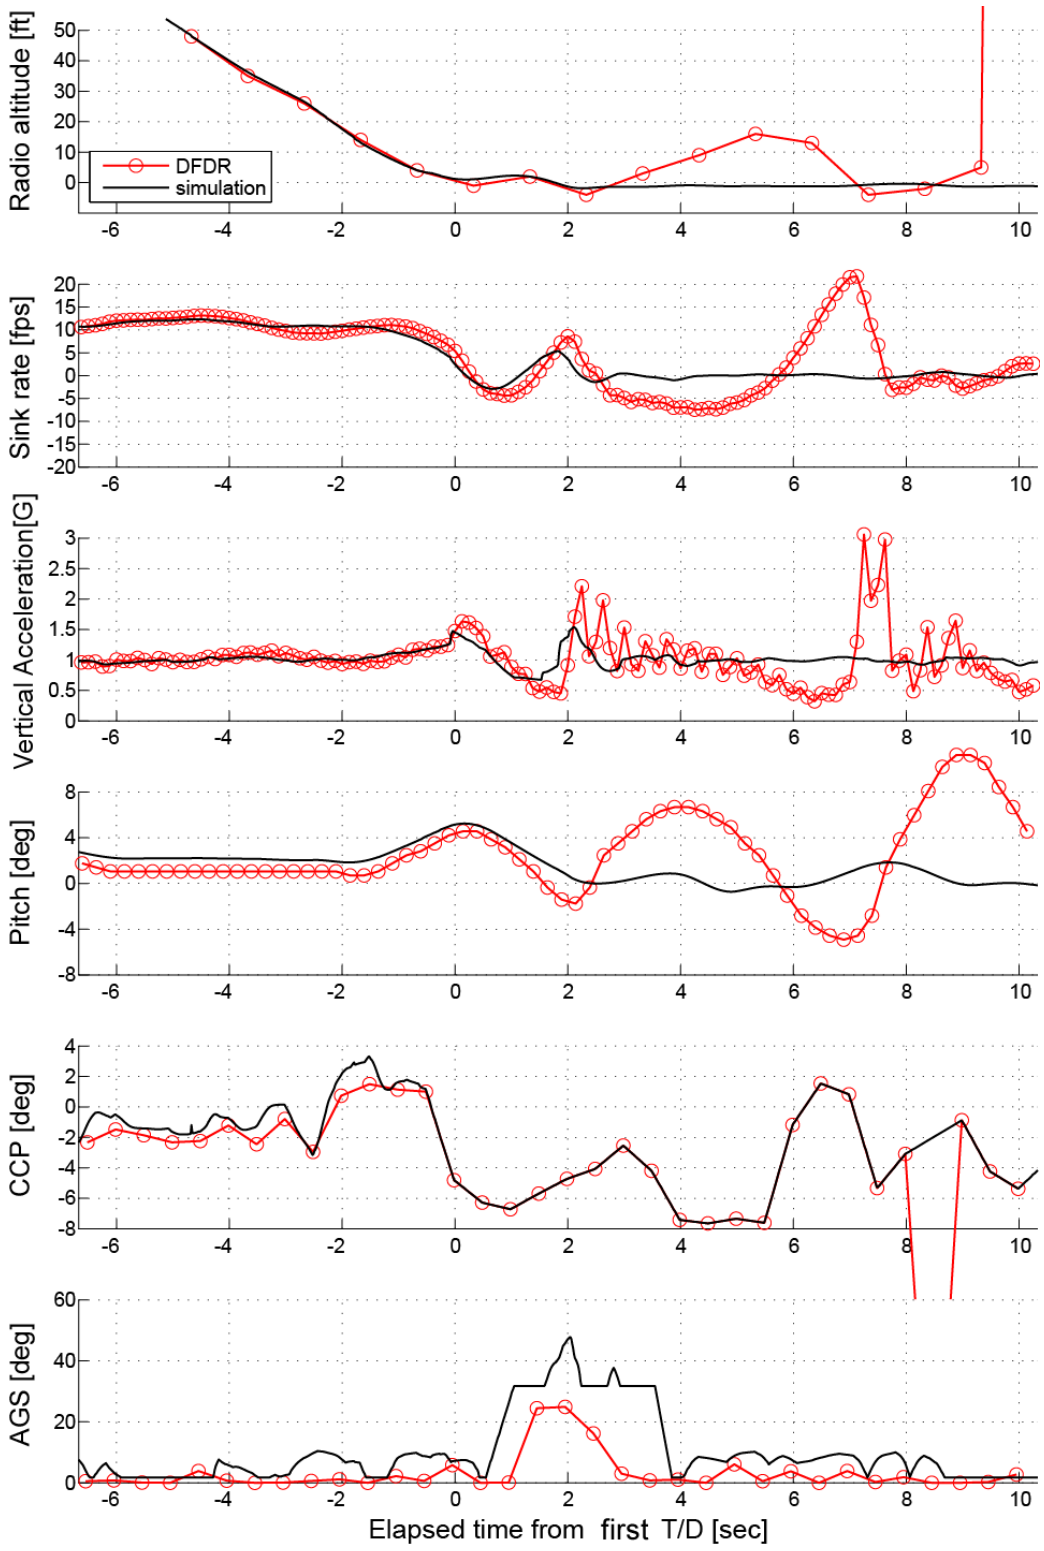
Figure 19　Simulation for a Case with Reduced Required Time for AGS Deployment

We examined the airplane behavior in the case where the required time for AGS deployment is 0.61 seconds—almost the half of that observed in the accident. The results are as follows: (Figure 19)

b. As the nose-down motion during the first bounce was restrained, the pitch angle upon second touchdown was positive—2.0º, and the airplane touched down on the MLGs. The loss of lift during the first bounce was also restrained since nose-down restraint brought a higher angle of attack. This resulted in a smaller sink rate at the touchdown—6 fps, smaller than 9 fps recorded in this accident.

c. Because the second touchdown was made on the MLGs, the NLG did not receive a bounce back from the runway surface resulting in very small nose-up moment after the second touchdown. On the other hand, the sink rate was smaller than that of the accident, so was the vertical acceleration on the second touchdown—1.5 G, smaller than that of the accident. These factors prevented any bounce from happening after the second touchdown.

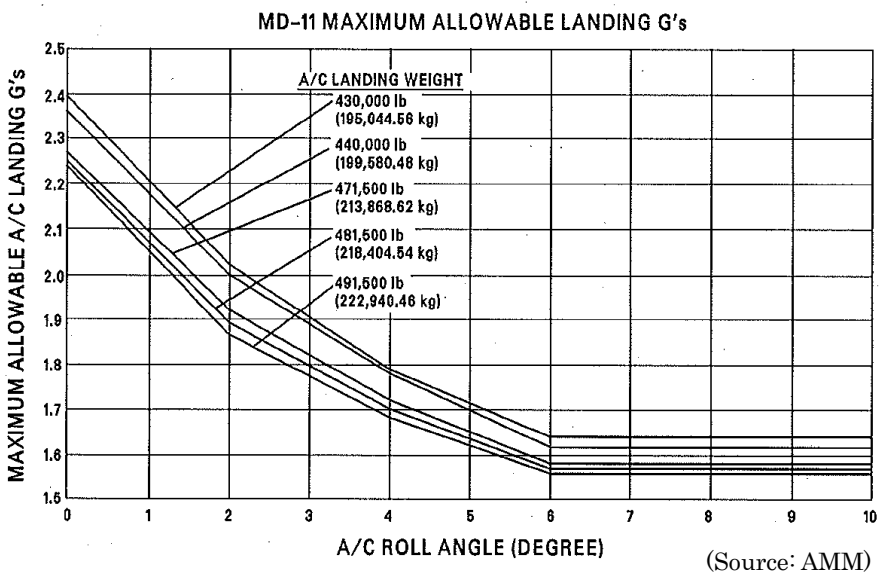
Figure 20 Landing G's vs Roll Angle

accelerations at the beginning of the touchdown, and the airplane roll and pitch attitude effects on the number of effective landing gears that absorb the landing energy. If the vertical acceleration at the beginning of the landing is less than 1G, the potential energy that is normally accommodated by wing lift may instead be transmitted into the landing gear.

D. Operators should evaluate the effects of pitch and roll and determine if a singular landing gear may have absorbed significant loading. To determine if such loading has occurred, use the landing G's vs roll angle graph. If still undetermined, operator may submit landing parameter to their Boeing Field Service Representatives of Boeing Service Engineering for analysis.
